Contract #: 04-0120F4Cty: SF/ALA Rte: 80 PM: 13.2/13.9File #: 69.28**WELDING INSPECTION REPORT****Resident Engineer:** Pursell, Gary**Address:** 333 Burma Road**City:** Oakland, CA 94607**Report No:** WIR-004337**Date Inspected:** 28-Oct-2008**Project Name:** SAS Superstructure**OSM Arrival Time:** 1400**Prime Contractor:** American Bridge/Fluor Enterprises, a JV**OSM Departure Time:** 2300**Contractor:** Zhenhua Port Machinery Company, Ltd (ZPMC), Changxing Island **Location:** Shanghai China**CWI Name:** Zhu Zhong Hai**CWI Present:** Yes No**Inspected CWI report:** Yes No N/A**Rod Oven in Use:** Yes No N/A**Electrode to specification:** Yes No N/A**Weld Procedures Followed:** Yes No N/A**Qualified Welders:** Yes No N/A**Verified Joint Fit-up:** Yes No N/A**Approved Drawings:** Yes No N/A**Approved WPS:** Yes No N/A**Delayed / Cancelled:** Yes No N/A**Bridge No:** 34-0006**Component:** Tower**Summary of Items Observed:**

## WELDING INSPECTION REPORT

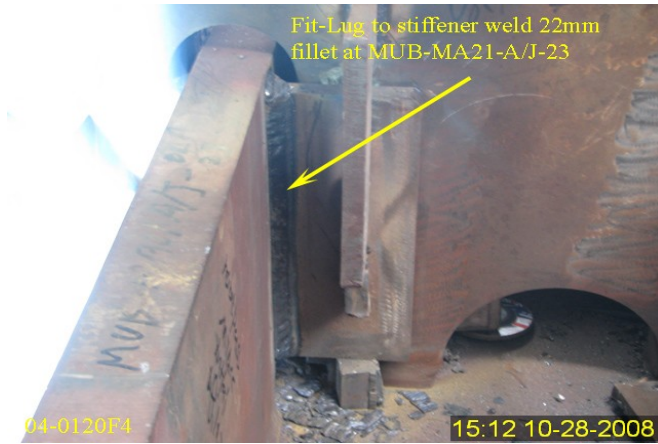
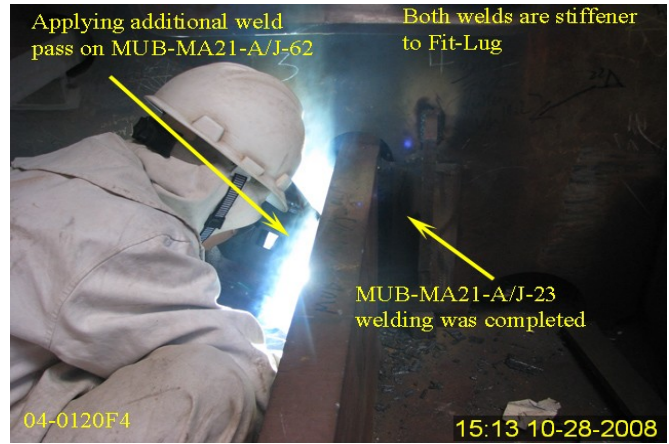
Caltrans QA Inspector observed that ZPMC had performed the welding of fit-lug to stiffener plate on 2 welds these welds were identified as MUB-MA21-A/J-62 and MUB-MA21-A/J-23. Upon the arrival of this QA inspector it was observed that ZPMC had completed the welding of both fit-lug to stiffener except for weld 62 that was determined to need one more weld pass to achieve the 22 mm size fillet weld. It was noted that ZPMC was using the Flux Cored Arc Welding (FCAW) process for these two welds as outlined in WPS-B-T-2231 with electrode E71T-1, 1.4mm diameter wire. The additional information was obtained by ZPMC QC (CAWI) inspector onsite Zhang Huang who is assisting the ZPMC CWI Zhu Zhong Hai. For weld number MUB-MA21-A/J-62 the multi-pass fillet weld received a total of 5 weld passes to achieve the 22mm weld size. During the welding operation the fit-lug that was "dogged" in place has moved to create an approximate 3mm gap which is within the tolerance of the new WPS, ABF-WPS-D15-F1202A for high nickel. The welding parameters obtained were 207 amps, 25.3 volts and travel speed of 113mm/min, the preheat temperature was 198°C prior to welding with welder Liu Xiaolin # 067079. Weld number MUB-MA21-A/J-23 the multi-pass fillet weld received a total of 4 weld passes to achieve the 22mm weld size. During the welding operation the fit-lug that was "dogged" in place has moved to create an approximate 7mm gap which is not within the 5mm tolerance as outlined in the new WPS, ABF-WPS-D15-F1202A for high nickel. ZPMC QC personnel Ken Zhang stated that ZPMC will wait for the weld to cool down and check the gap again and if there is no change, ZPMC will determine how to bring the gap within tolerance. The welding parameters obtained were 213 amps, 25.5 volts and travel speed of 116mm/min, the preheat temperature was 203°C prior to welding with welder Wen Yangyan # 066734. The time ZPMC completed welding was 1520 hrs and a temperature of 210°C for the start of the controlled cool down process with ZPMC checking the temperatures every 15min and recording them every 30min. below is the cool down rate tracking being performed.

During the controlled cool down after the completion of welding ZPMC and ABF was monitoring the cool down rate as observed by this Caltrans QA Inspector. During the odd hour of 1750 hrs to 1950 hrs it was determined that the cool down rate exceeded the maximum allowable temperature of 40°C per hour as outlined in submittal SUB101R2 by 3°C.
